Texas Clean Rivers Program

San Antonio River Basin 2018 Summary Report

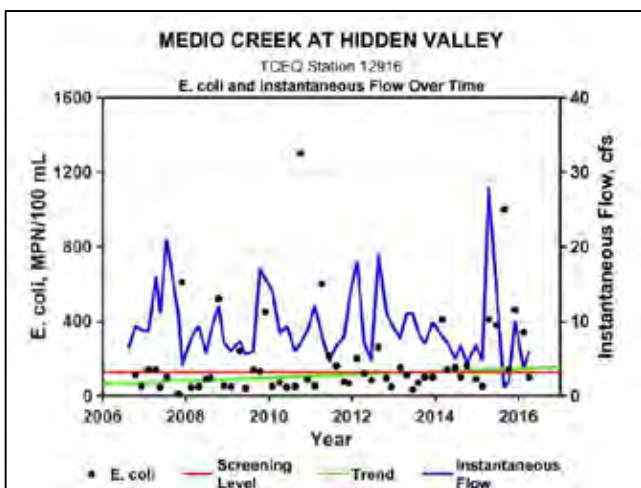
Example A: 12916 Medio Creek at Hidden Valley, E. coli over Time

Select station(s) with statistical significant parameter trends, either increasing or decreasing (↑ or ↓) will be discussed in each of the Watershed Quality Summaries trending sections, including the parameter concentration and flow over time, and the parameter concentration versus flow. Parameters with insufficient trending data or non-statistical significant information may also be identified and included to support possible improvement or decline of water quality. Additional statistical significant parameter trends, either increasing or decreasing (↑ or ↓) are also identified at the bottom of each 2014 IR Summary of Impairments, Concerns and Long-Term Trends by Segment Assessment Units Tables. For graphical illustrations of parameter concentration and flow values time, measured parameter values are represented by the black dots (•) and flow values are represented by the solid blue line (—). The red line (—), when applicable, represents either the parameter standard or screening level (SL). The parameter's trend-line against time is shown in green (—). Trending details can be seen in Appendix C at the end of this report. An example from Station 12916 Medio Creek at Hidden Valley Campground can be seen in Example A and B.
